Identification and Correction of Deficient Work

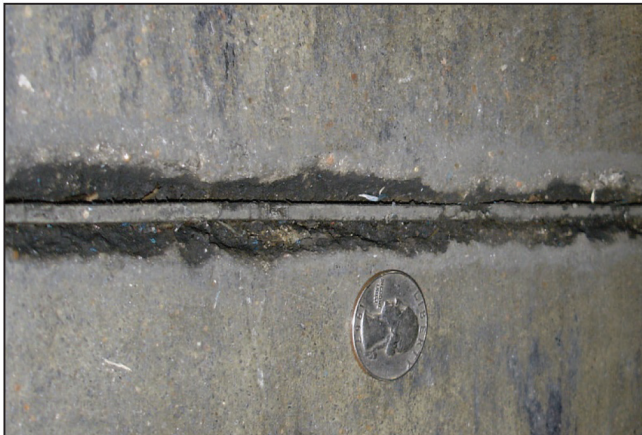
To be effective as a joint edge protector, a semi-rigid filler must rest on the shelf at the base of the saw cut or be well adhered to the joint walls at least 2" (50 mm) deep to compensate for the lack of base support.

Indication: The most obvious sign of less-than-proper filler depth, is when the joint filler is depressed below the surface of the floor or falls into the joint after opening occurs.

Correction: Remove existing filler completely, clean joints properly as outlined in Metzger/McGuire Installation Guidelines and refill properly.

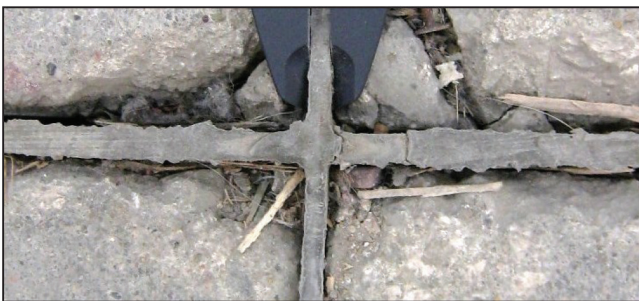
Note: Joint edges may have deteriorated (spalled) as a result of hard-wheeled traffic crossing the inadequately protected joint. If spalling has occurred refer to Metzger/McGuire's Guide to Basic Floor Repair for standard spalled joint repair details.

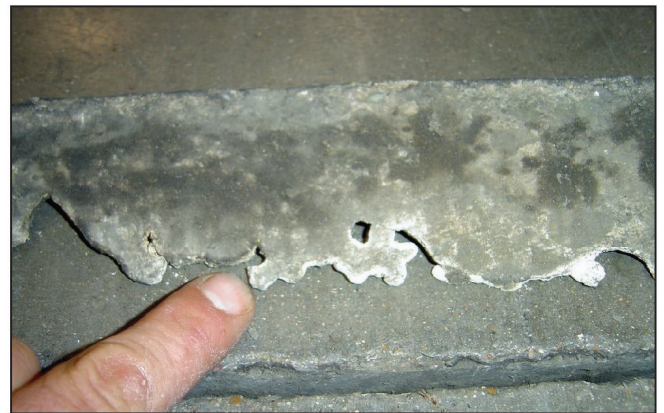
Dry-cut sawing is the best means of achieving a clean joint. If debris or residue from sealers, etc. remain on the joint walls, filler-to-wall adhesion can be compromised.

Indication: Improper cleaning is detectable by inspecting the sides of cured filler removed from the joint. If dirt or debris are embedded in the filler, inadequate cleaning is indicated.

Correction: Remove existing filler completely, clean joints properly as outlined in Metzger/McGuire Installation Guidelines and refill properly.

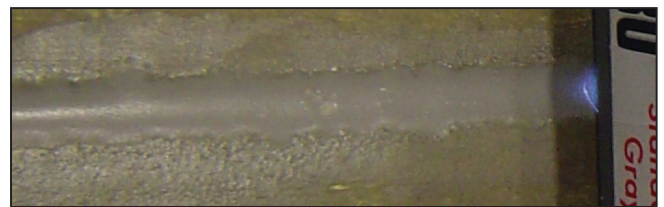
To be effective as a joint edge protector, finished filler profile must be flush with the floor surface and provide a smooth, interruption-free transition across the joint. A concave or "dished" filler profile leaves joint edges exposed as impact points, and thus subject to deterioration under hard-wheeled traffic.

See [Technical Bulletin T8](#) for discussion of indications and correction of low profile filler.
