**Floor Joint Filler Color Change**

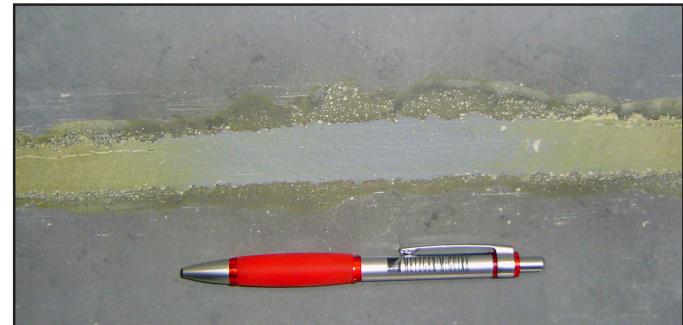
In addition to lighting, over time we have observed a number of jobsites where environmental conditions appear to lead to more severe color changes-a shift in epoxy filler color from gray to yellow or bright yellow. Typical conditions include material installation in colder temperatures, often accompanied by the use of a temporary heating source in the building such as propane or natural gas. In some cases, an additional variable such as a curing compound or chemical admixture may also play a role. On projects where extreme yellowing of epoxy joint filler occurs, it is common to see similar yellowing in other fillers and sealants used in the building. The best way to avoid potential yellowing is to defer joint filling until the building is under permanent climate control. If the project schedule does not allow for delaying the joint filling, please contact our office to discuss project conditions and strategies to minimize the potential for extreme discoloration.

*Extreme discoloration typically occurs only when a variety of factors are at play including UV exposure along with installation at cold temperatures and/or in the presence of temporary heating sources.*

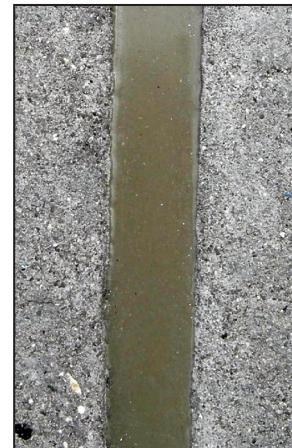
On some projects, the color change can occur almost immediately after the filler has been installed. On others, the change may be more gradual. When color change does occur on a project, it often leads to questions about whether the material is defective, or whether the installer "did something wrong." In most cases the answer is "no." A majority of filler discoloration can typically be tied back to a facility's lighting. Certain lighting systems can emit UV rays within a spectrum that can actually cause discoloration of the filler, or which simply render the filler's appearance to be different. This is typically noted as a slight "greening" of the gray filler.

*The most common level of discoloration is a slight "greening" of a gray filler, often resulting from UV exposure.*

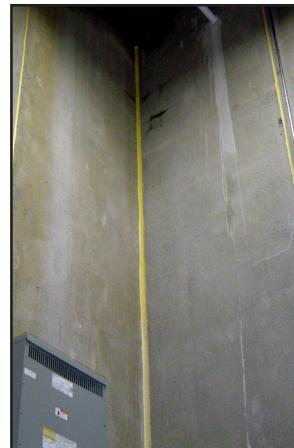
*Photo taken at same project as photo above shows similar yellowing occurring on vertical wall panel sealants.*
