## Joint Filler Protrusion in Covered Floors

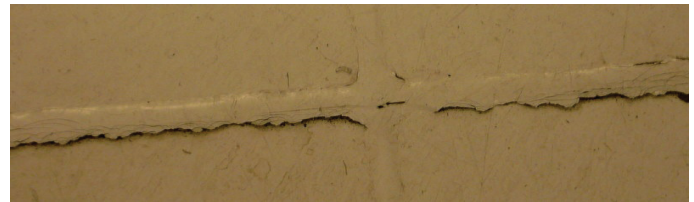
When a floor covering is applied the slab is encapsulated. Since nature always seeks equilibrium, the moisture on the bottom gradually migrates upward. When moisture is added to the dry upper portion, it results in an expansion of the concrete. When sufficient expansion takes place, the semi-rigid filler is compressed. Since the filler is restrained on the bottom, it is literally extruded upward and out of the joint. This is the bulging callers describe.

*Example of filler protrusion under coated floor*

Slab re-expansion can be verified by removing the VCT or coating and examining the filler. If the filler is thoroughly cured and of consistent hardness, you can be certain that the bulging is slab-related.

Correction of filler bulging is an inexact science. If you razor off the protruding filler flush with the floor surface, and replace the surface covering, there is a reasonable chance that the problem will not recur. However, we have encountered floors where protruding fillers had been removed, only to have bulging recur several weeks or months later. There is no way to predict successful correction, since it all depends on how much moisture remains in the lower portion of the slab and/or the potential that external moisture sources (i.e. drainage) are playing a role.

We estimate filler protrusion occurs in less than 5% of all covered floors. The problem is that no one can predict when, or why, it will occur. Accordingly, it has become our standard recommendation that joints under floor covering NOT be filled with a semi-rigid epoxy or polyurea. Instead, we suggest that joints be filled with a material that will yield to compressive forces without extruding upward. Some contractors have found a weak mortar suitable.

If there is a compelling reason to fill joints under coatings, tile or other coverings with a semi-rigid, we recommend that filling be performed 10-20 days after slab placement. In this way the filler will separate early, leaving a gap that can accommodate some joint closure before the filler is placed in compression. Contact our technical staff for advice on which Metzger/McGuire filler to use and how/when to install.
