Filling Joints in Curled and Rocking Slabs

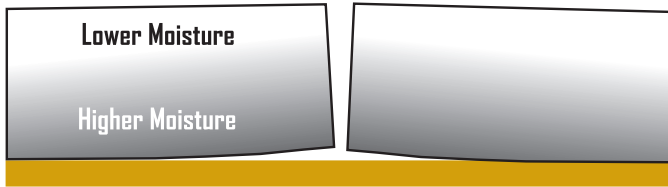
Evaporation reduces the moisture content in the upper portion of the slab, but the moisture content in the lower portion remains high. This moisture gradient variation can lead to a condition known as slab curl.

Exaggerated profile view of the slab curl phenomenon

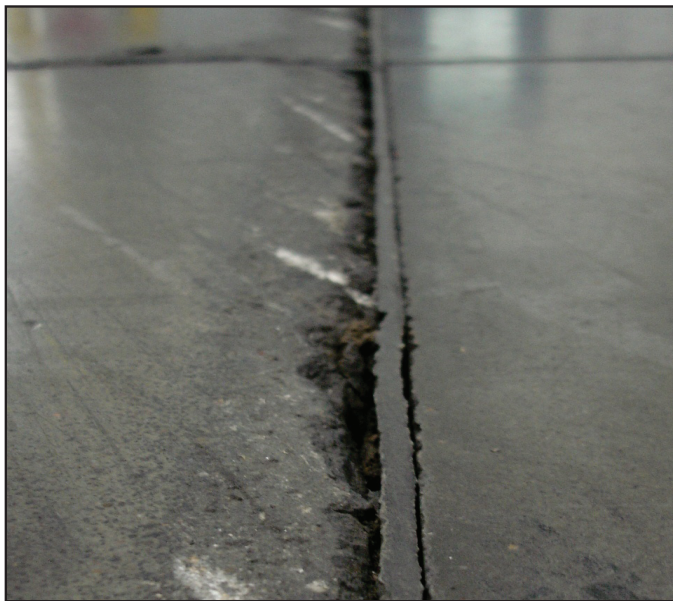
Curled slab panels create impact points for material handling vehicle wheels, and joint edges along curled panels can quickly deteriorate if left uncorrected.

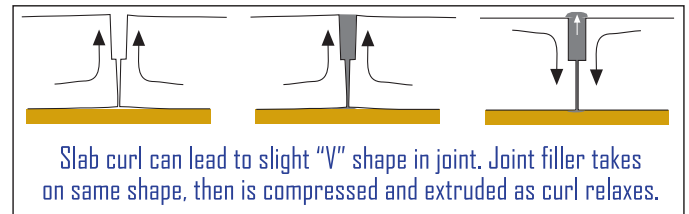
the adjacent slab remains in its original higher position, and thus the joint edge is vulnerable to hard wheel impact and spalling. Even without wheel impact, the semi-rigid joint filler's protection will be compromised as it shears away from its bond to the joint walls.

In some cases, slab edge curl may relax, and the slab will return to its original position. Should this occur, the joint filler may be compressed and literally extruded upward with its top above the floor surface.

Slab curl and/or rocking affects on joint fillers.

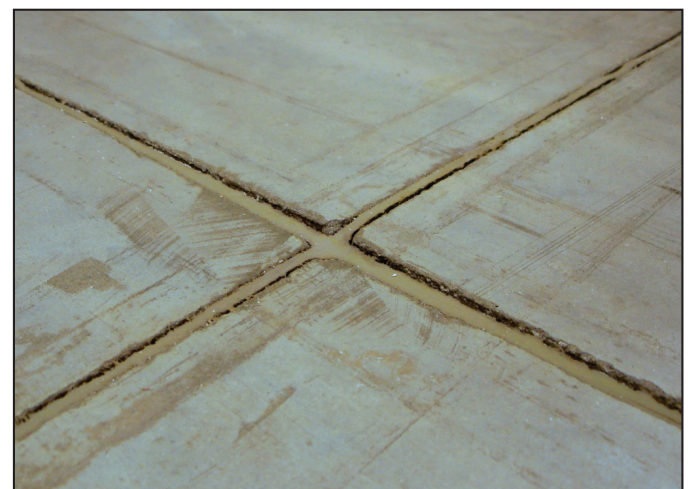
Curled or rocking slab panels can compromise the ability of the filler to provide proper edge protection.

No semi-rigid joint filler can remain effective as an edge protector if slabs are significantly curled or are rocking. If rocking or slab curl conditions are detected on a project prior to the start of joint filling work, we recommend that filling be delayed until the effect of the curl/rocking conditions on the joint filler, the durability of the floor, and potential correction methods can be discussed by all involved parties.
