JOINT FILLER TECHNICAL BULLETIN

Joint Filler Separation; Causes and Corrections

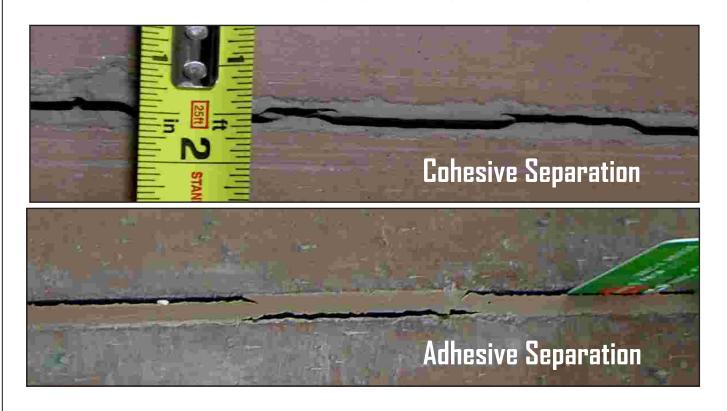
Separation Can Be Adhesive, Cohesive, Or Both

When joints open beyond a filler's expansion capability, fillers separate. They may separate adhesively at their bond with the concrete. Or they may separate cohesively (internally). On the same job you may see both types.

Semi-rigid epoxies will most often separate adhesively, and usually in a leapfrog manner, alternating from side-to-side. Polyureas tend to separate adhesively, and usually on only one side in a continuous split.
