Joint Filler Protrusion in Exposed Concrete Floors

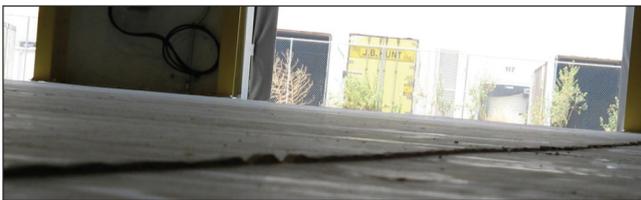
When floors expand, the difference can be measured at the joints. The same joint can be 1/4" (6.35 mm) wide in December and 1/8" (3.17 mm) wide in July. You will generally not notice the joint width change if the joints are not filled. But if the joints are filled, you can tell immediately how much the slab has expanded or contracted.

Example of filler protrusion in building with no climate control

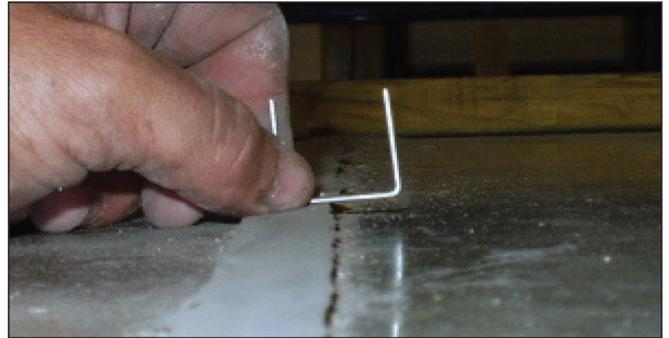
On many projects the joints are filled before the HVAC is turned on. If the joints are filled while the ambient temperature is cool, and then the heat is turned on, the increase in temperature can cause slab expansion, which in turn causes joints to narrow, causing filler extrusion.

Example of filler protrusion in exposed floor
