Joint Filler Protrusion in Exposed Concrete Floors

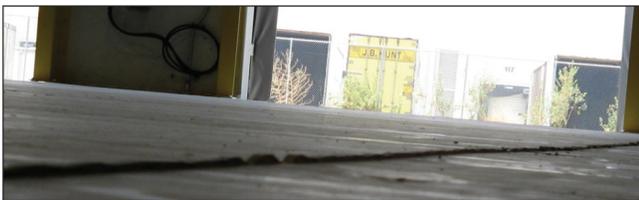
Example of filler protrusion in building with no climate control

When floors expand, the difference can be measured at the joints. The same joint can be 1/4" (6.35 mm) wide in December and 1/8" (3.17 mm) wide in July. You will generally not notice the joint width change if the joints are not filled. But if the joints are filled, you can tell immediately how much the slab has expanded or contracted.

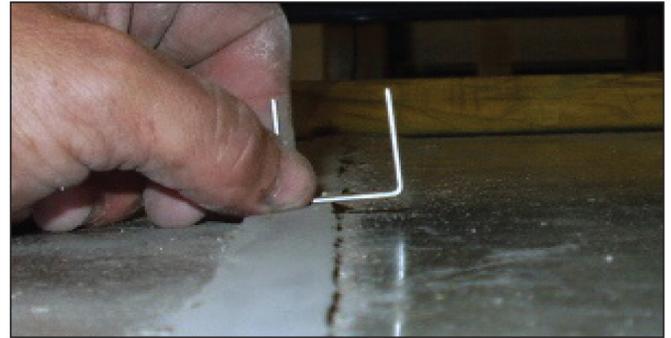
Example of filler protrusion in exposed floor

On many projects, the joints are filled before the HVAC is turned on. If the joints are filled while the ambient temperature is cool, and then the heat is turned on, the increase in temperature can cause slab expansion, which in turn causes joints to narrow, causing filler extrusion.
