Industrial Concrete Floor Joint and Surface Condition Monitoring and Maintenance

By Scott Metzger, Metzger/McGuire Co.

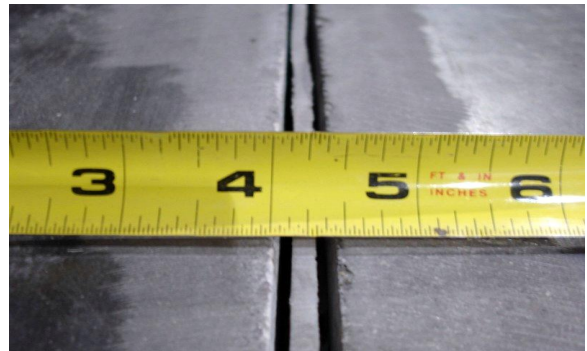
Right: Example of filler collapse in joint experiencing substantial opening...

Sections of joint filler which experience complete adhesion loss in the presence of substantial joint dimension opening can be “punched down” below the joint edge, exposing edges to impact. This would normally only occur in the presence of extreme joint opening (i.e. joint opens wide enough for filler to be driven below base of saw cut) or if there were underlying deficiencies in the original filler installation (i.e. shallow joint filler depth, placement over compressible foam rods or debris, inadequate joint preparation/cleaning, etc). Procedures for repairing depressed filler can be found under Concave/Low Filler Profile in M/M’s Guide to Basic Floor Repair.

Typical repair of joints exhibiting filler collapse involves removing existing filler, re-chasing or saw cutting joint to establish clean, structurally sound edges, and refilling the joint with a semi-rigid epoxy (ambient temperatures) or semi-rigid polyurea (freezer/cooler rooms or for faster access). If deteriorated joint width exceeds 1 ½” (38 mm) structural rebuilding of concrete edges may be desirable for optimal long term durability.

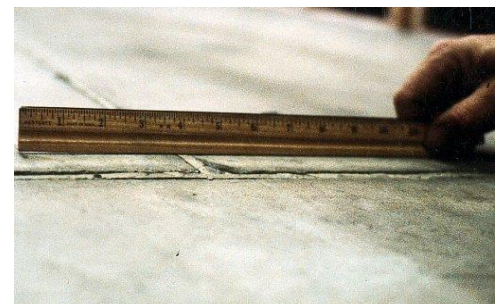
Right: Example of slab edge curl...

Joint edge curling is readily identifiable by a difference in joint edge elevation across any given joint. Slab edge curl is inevitable to some degree on virtually every industrial floor. While the causes of curl are many and still the source of much disagreement within the industry, in very basic terms edge curl occurs as a result of slab panel edges or ends drying faster than the center of the slab panel, leading to a curling or warping effect similar to the behavior exhibited by a wet sponge left to dry out.

Depending upon the degree of curl, it may not present any problem at all or it may be a condition requiring corrective action. Slab edge curl warranting assessment and potential corrective action should be evident as the joint edge will begin to exhibit spalling/deterioration under material handling vehicle traffic (the higher joint edge being impacted and chipped away). In our experience, generally this condition is identified shortly after the floor is placed and is not as likely to occur in areas where it was not previously identified within the first 6 months in the life of the floor. If slab curl condition is present to the degree that it is impacting material handling operations, leading to joint deterioration, or if panels show evidence of “rocking” as vehicles cross the joint, it is important to bring in an engineer, consultant or trusted industrial floor resource to determine potential need for correction and the best long term correction options.

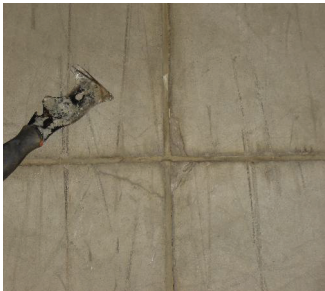
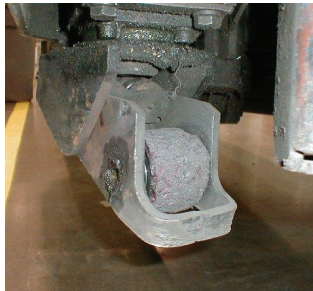
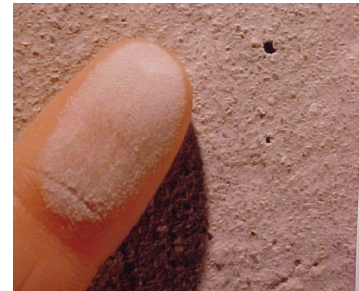
Above: Photo to left shows joint spalling and gouges possibly resulting from dragging of hard objects. Photo in middle shows excessive wheel wear, generally a result of poor floor maintenance and cleaning procedures or floor surface defects impacting wheel. Photo at right shows dusting, generally a result of original finishing practices or excessive surface wear.
