Industrial Concrete Floor Joint and Surface Condition Monitoring and Maintenance

By Scott Metzger, Metzger/McGuire Co.

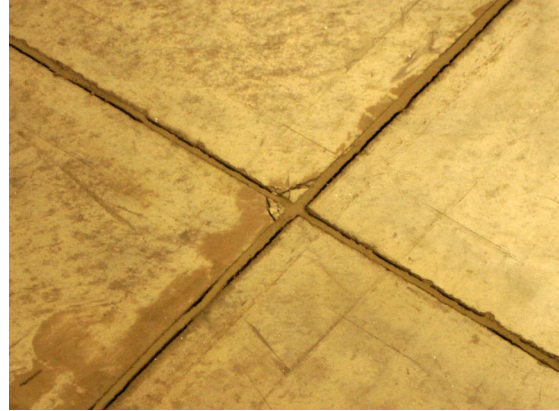
As with any building component, industrial floor joint filler may require periodic maintenance to ensure optimal performance. Joint edge damage (spalling) can result from lack of attention and proper maintenance.

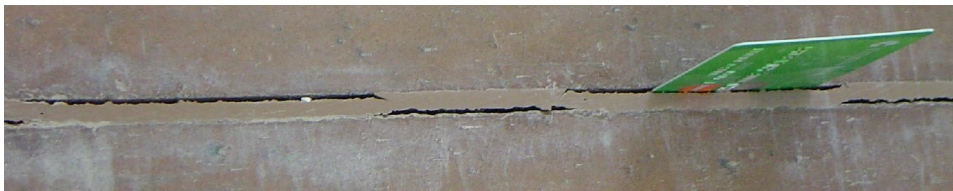
Separation Void at Credit Card Width 1/32” + Maintenance Suggested

Separation voids will generally first be seen as dark hairlines within material or along joint edges. Voids are usually not a concern to the structural integrity of the filler and its ability to protect unless they open to a width of 1/32” (credit card width) or greater. Even when voids do occur to this extent, potential exposure to joint edge damage will be dependent largely on the location and pattern of the voids. Internal separation (tears within filler) require less maintenance as they do not lead to joint edge exposure. Separation voids which jump back and forth across the joint or occur dominantly along one edge may require refilling if they exceed credit card or if there is evidence of joint edge deterioration/breakdown occurring at void locations.

If evidence of edge deterioration is present, voids should be cleaned and filled with a semi-rigid polyurea filler. Voids showing no evidence of compromising joint edge integrity should be monitored monthly to determine overall activity over a period of time. If voids remain at consistent width over the period of 6 months, refilling activity can be considered. But it is more likely that void dimension will open and close seasonally to some degree. If no signs of joint edge deterioration are present sanitation issues are not a concern filler separation voids generally will not require maintenance. If either concern is present, refill the voids.

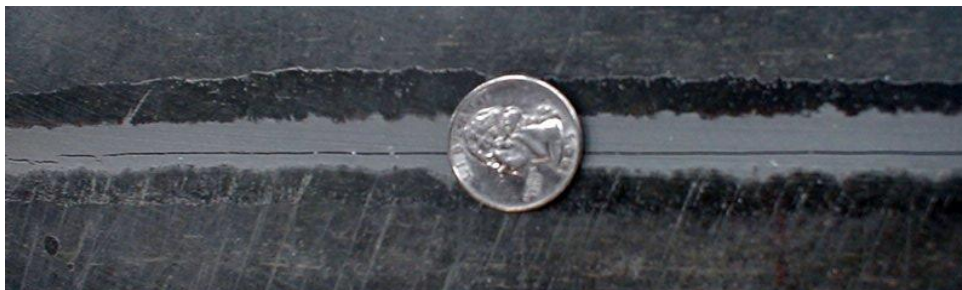
Early, Minor Separation Void – No maintenance generally required

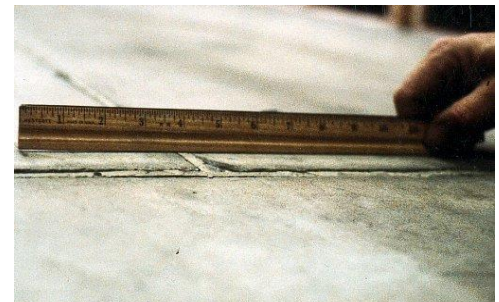
Right: Example of slab edge curl...

Joint edge curling is readily identifiable by a difference in joint edge elevation across any given joint. Slab edge curl is inevitable to some degree on virtually every industrial floor. While the causes of curl are many and still the source of much disagreement within the industry, in very basic terms edge curl occurs as a result of slab panel edges or ends drying faster than the center of the slab panel, leading to a curling or warping effect similar to the behavior exhibited by a wet sponge left to dry out.

Depending upon the degree of curl, it may not present any problem at all or it may be a condition requiring corrective action. Slab edge curl warranting assessment and potential corrective action should be evident as the joint edge will begin to exhibit spalling/deterioration under material handling vehicle traffic (the higher joint edge being impacted and chipped away). In our experience, generally this condition is identified shortly after the floor is placed and is not as likely to occur in areas where it was not previously identified within the first 6 months in the life of the floor. If slab curl condition is present to the degree that it is impacting material handling operations, leading to joint deterioration, or if panels show evidence of “rocking” as vehicles cross the joint, it is important to bring in an engineer, consultant or trusted industrial floor resource to determine potential need for correction and the best long term correction options.

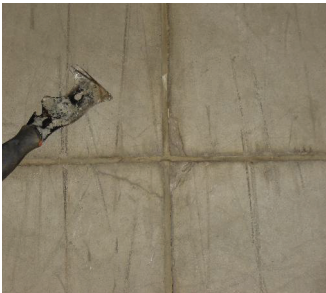
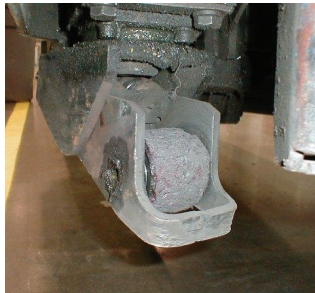
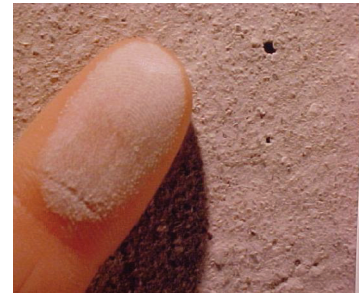
Above: Photo to left shows joint spalling and gouges possibly resulting from dragging of hard objects. Photo in middle shows excessive wheel wear, generally a result of poor floor maintenance and cleaning procedures or floor surface defects impacting wheel. Photo at right shows dusting, generally a result of original finishing practices or excessive surface wear.

Potential surface deterioration issues should be readily identifiable visually, the most likely being scratches, gouges, etc. A vast majority of surface defects result from abuse directly related to material handling vehicles and material handling practices. Scratches and gouges often result from inadequate cleaning of the floor and the subsequent friction resulting from debris, wood slivers from pallets, nails, etc being dragged under the wheel of a material handling vehicle across the floor. Improper driver material handling practices such as pallet dragging, pallet pushing, driving with forks dropped, dropping loads too quickly, etc. are all the most likely contributors and causes to any floor surface defects which might become visible. If signs of substantial or abusive surface wear, our recommended first step is to work with the material handling vehicle operators to identify the practices leading to the deterioration and work to change the practices suspected as the most likely cause.

- Signs of spalling, chipping or other deterioration
- Signs or evidence of dusting or gradual erosion of surface
- Any defect/deterioration areas where impact can be felt by MHV operators
- Areas exhibiting wear/damage that appears to be unusual or develops/changes rapidly
